HICKS ARCHITECTURAL GROUP

Exterior Inspections and Condition Assessment Report for Suburban Residential Complex

Niles, IL

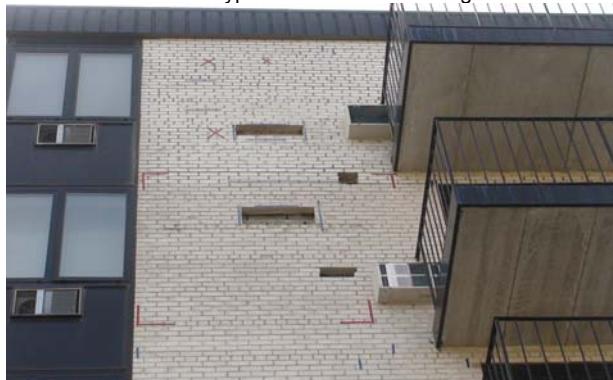
Elevation During Investigation
