Existing Visible Distress for Prototype Wall Replacement

Terrace Square Condominium Association

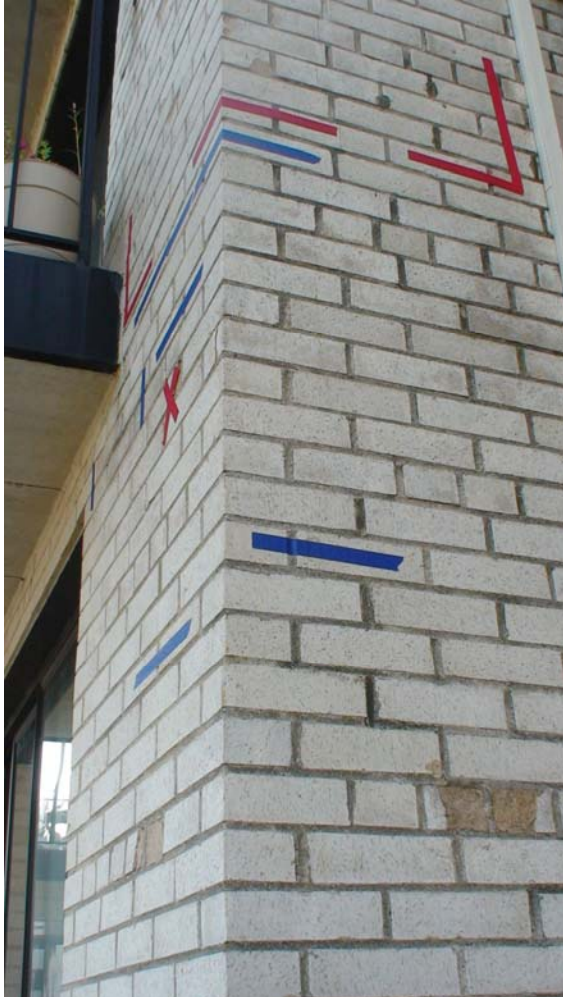
As part of HAG's inspection work at Terrace Square Condominiums, a multi-floor test area of distressed exterior face brick was removed at one building for several reasons. The representative condition of the masonry was inspected by our team and digitally photographed to record the current construction of the wall. A latent construction defect, creating a common source point for water infiltration through walls of this type, was observed. Masonry materials were collected for laboratory testing confirmed that original brick was sound.

With this information, a team that included The Structural Shop (consulting engineers) developed a prototypical method to match and most efficiently repair similar conditions of this type, when it is to be encountered as part of future work for the buildings. Repair work involved replacing the existing multi-wythe header brick assemblies with standard running bond face brick set onto flashed steel shelf angles.

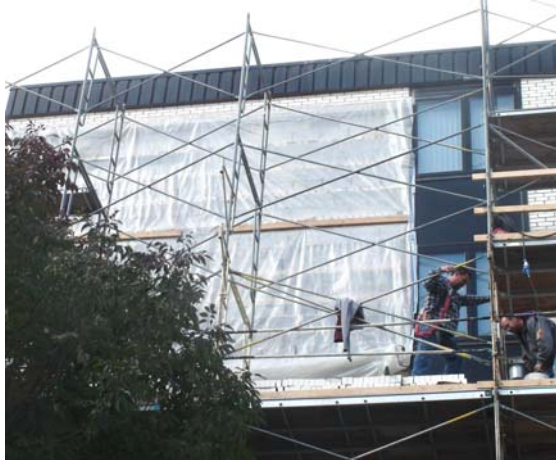
Prototype Wall Replacement in Progress

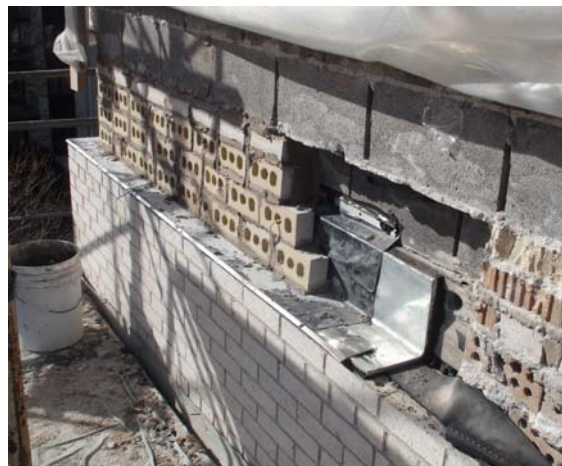
Shelf Angle Installation at Prototype Wall Assembly
