**Balcony Mitigation Repairs
for Suburban Residential Complex**
Niles, IL

Client:

Terrace Square Condominium Association

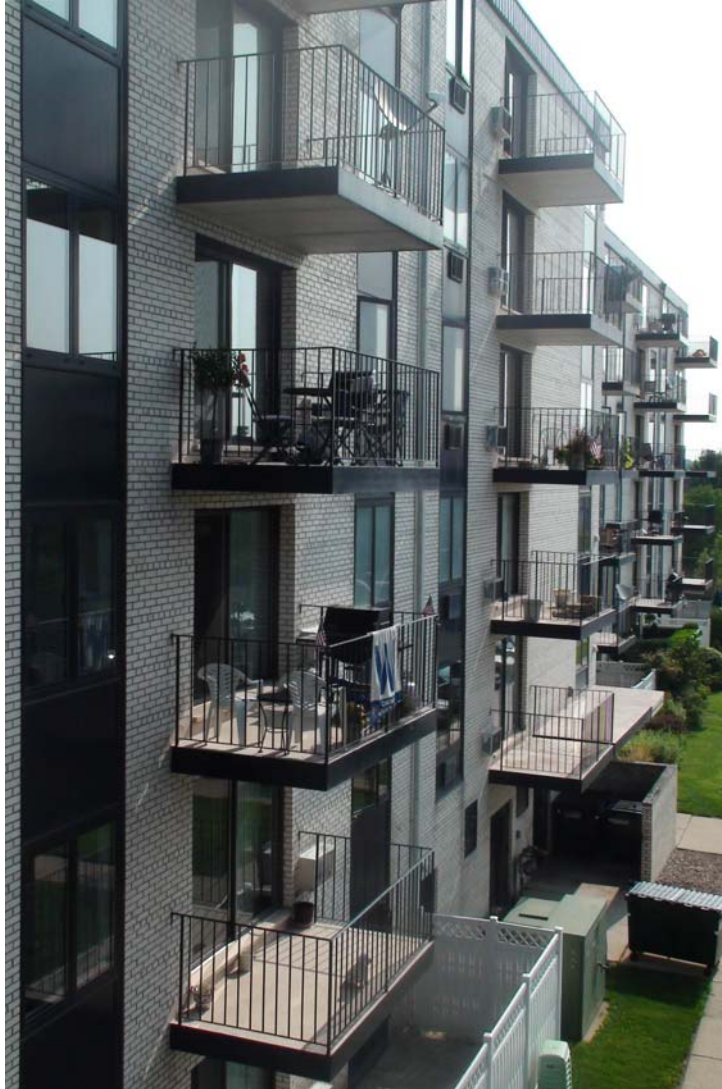
View of Typical Balcony Tier

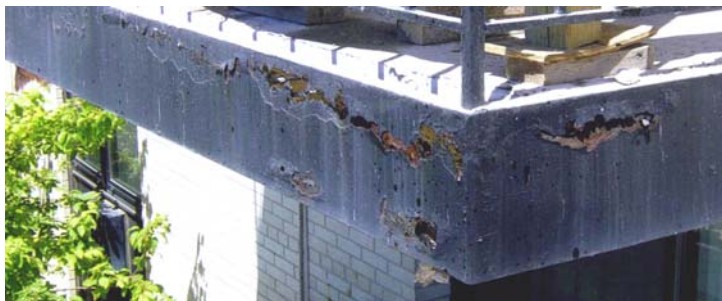
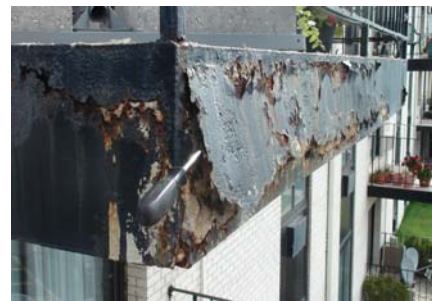
Close-up Photos of Typical Balcony Deterioration

As part of our investigation, it was discovered that many resident balconies were originally designed in ways to allow water to prematurely age the precast concrete structures and steel guard rail assemblies and enter the buildings. Railings were found to violate current building code strength and picket spacing requirements.

After sounding the undersides of 270 balconies with visible distress, our team determined fifteen balconies to be imminently hazardous. These required demolition and the design of long-lasting replacement balconies to most closely match the appearance of all the remaining balconies. For this, our work included:

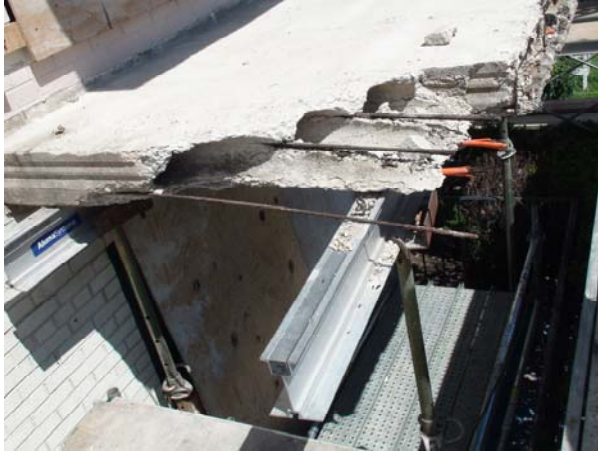
Partial Demolition of Existing Distressed Balcony

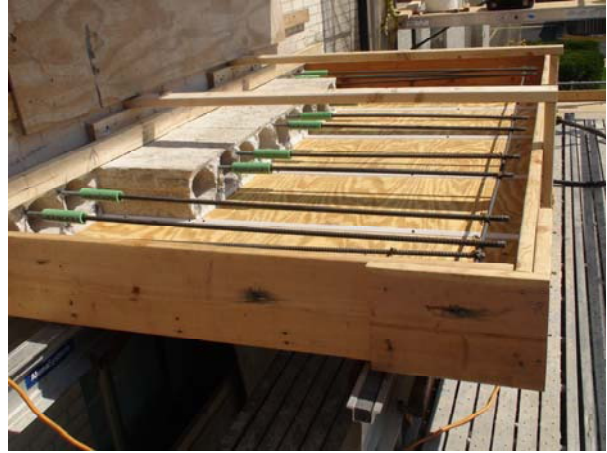
Replacement of Steel Reinforcement, prior to Casting Deck

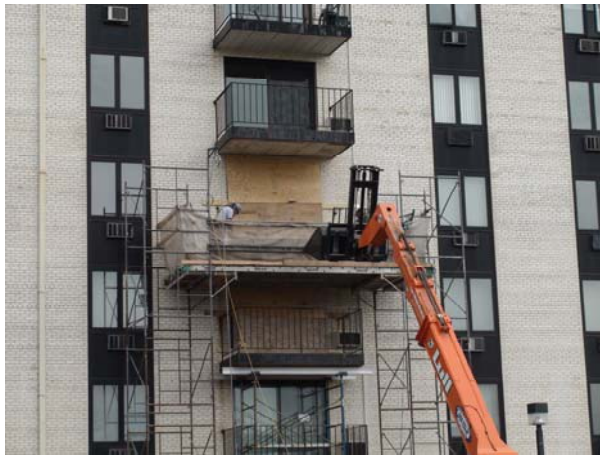
Pouring the Replacement Balcony Concrete Structural Deck

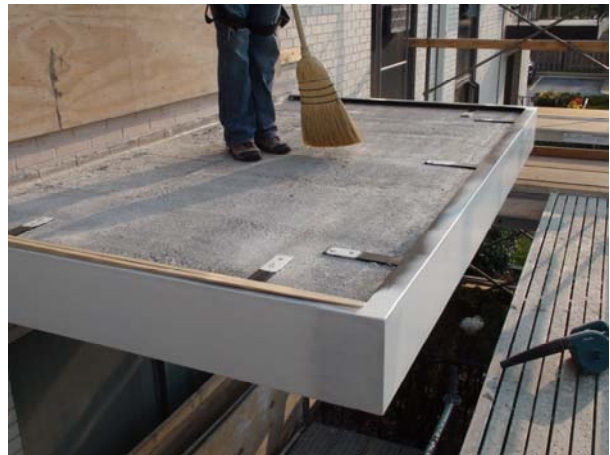
Installation of New Topping Slab and Matching Perimeter Steel

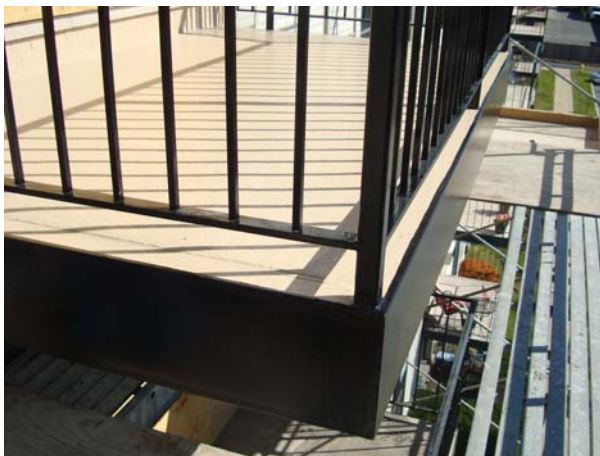
Installation of Prefabricated Replacement Painted Steel Railing

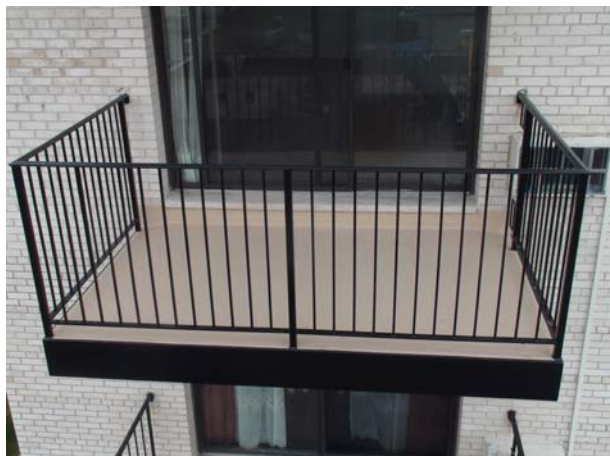
View of Completed Balcony Construction with Traffic Coating
