View of the 8-story, 126-unit Condominium Block

6300 N Sheridan Condominium Association

This condominium, built in 1964, experiences widespread leaking through the exterior masonry curtain wall, sagging masonry lintels and masonry step cracking.

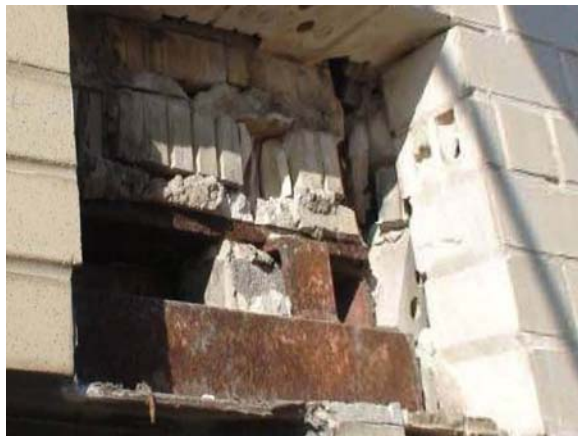
View of Typical Inspection Opening

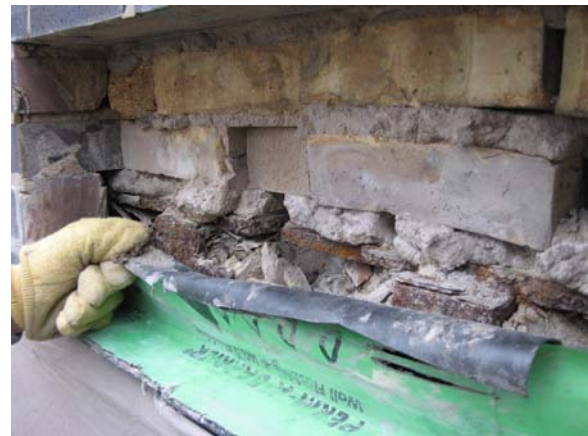
Flashing Set Into Inspection Opening, Prior to Rebuilding
