Catholic Theological Union

After determining the extent of the exterior distress, HAG provided restoration and repair services for the aging home of the Catholic Theological Seminary.

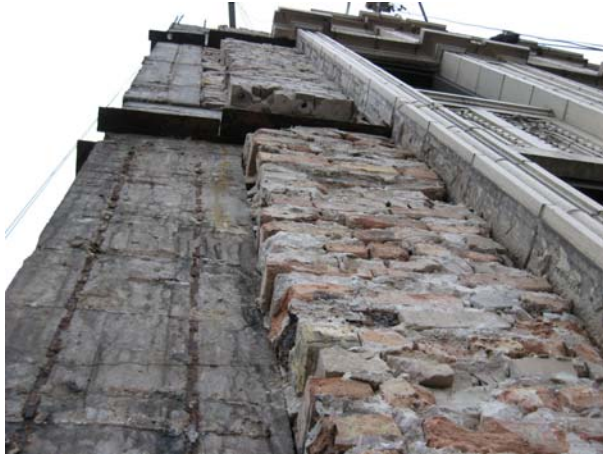
Demolition: Building Corner

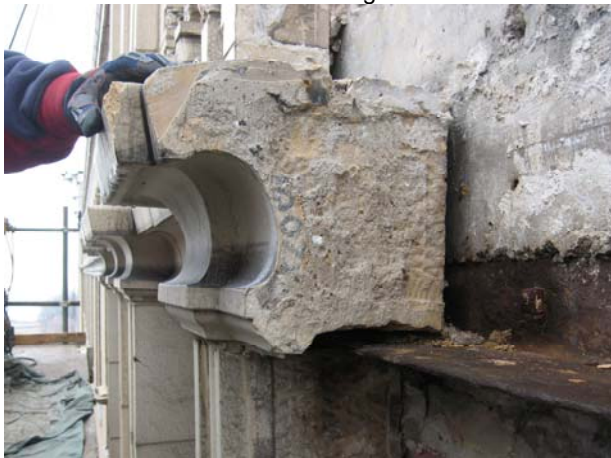
Salvaged Terra Cotta Repairs

- The design of mitigation repairs and replacement of damaged areas of existing masonry
- The design of mitigation repairs to salvaged terra cotta, saving the Owner from requiring costly replacement pieces and maintaining the best aesthetic for the work
- The design of replacement steel support shelf angles and associated flashings and weeps
- Preparation of construction documents for competitive bidding and permitting
- The determination of construction mock-ups to review material matches for replacement materials and establish quality standards for the work
- Construction observation services to routinely check, review and record the quality of the work during the construction period

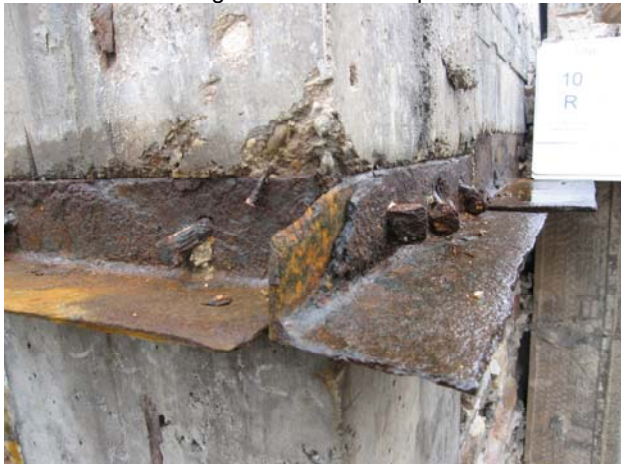
Existing Corroded Shelf Angles

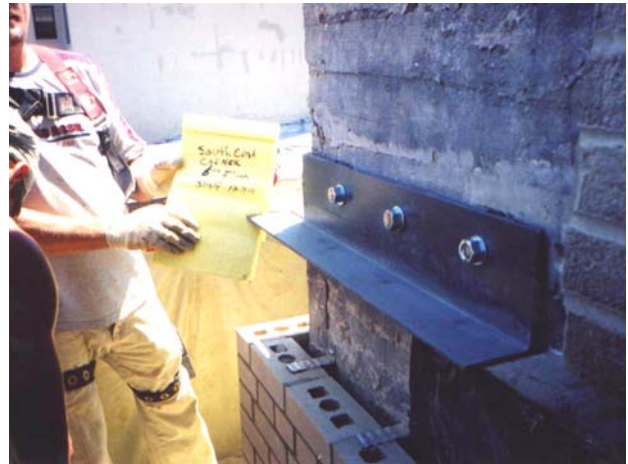
Installation of Replacement Shelf Angles
