22,500 s.f. Residential Common Courtyard Renovation at Terrace Square Condominiums

22,500 s.f. Residential Common Courtyard Renovation & Garage Re-Roof for Suburban Residential Complex Park Ridge, IL

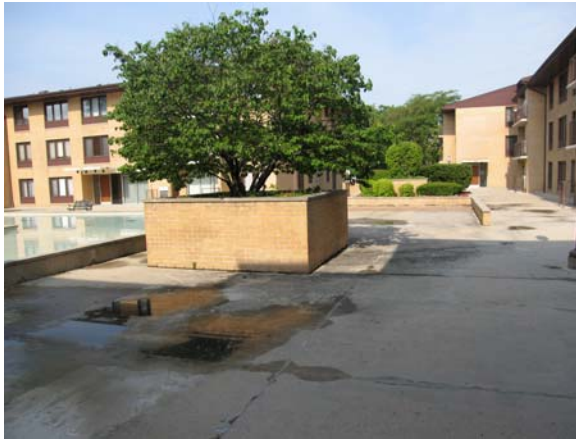
Courtyard Prior to Renovation

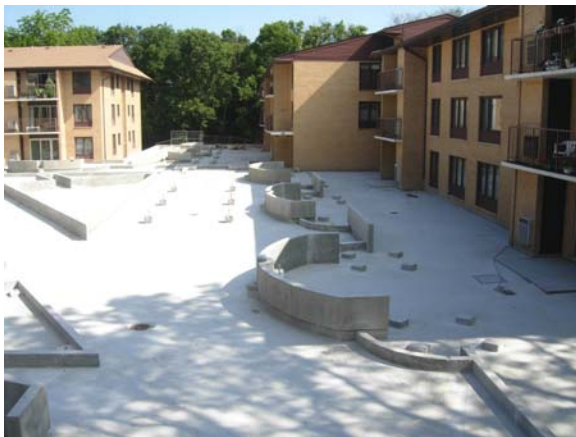
Construction Photo of Renovation

- Structural reinforced concrete deck repairs and a 20 yr. material warrantied waterproofing system for the 22,500 s.f. garage roof / plaza
- The selection of the sand bed-set brick paving system for ease of maintenance to access waterproofing in the event of future work and aesthetics
- The design of intensive and extensive landscaping around natural pathways through the site and arranged to provide more privacy to first-floor residents with windows facing the courtyard
- The design of a new shading pergola, reflection pool, path security & landscape lighting

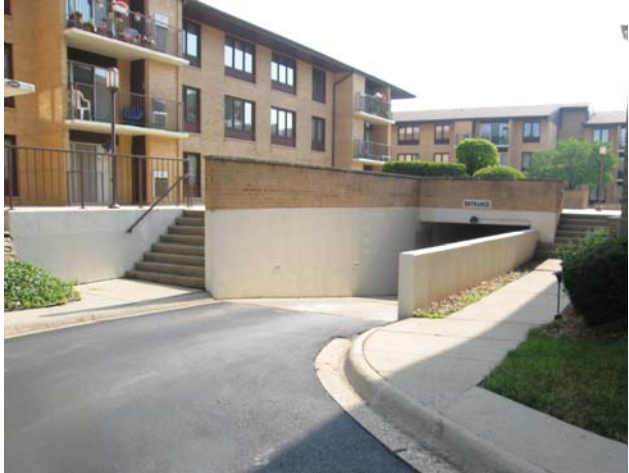
View of Garage Entry Prior to Renovation

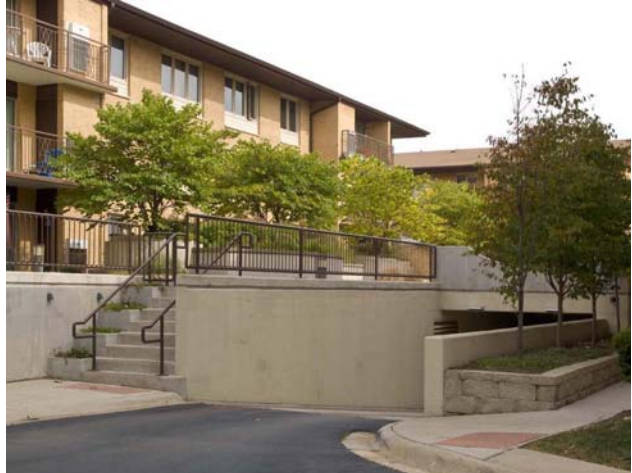
View of Garage Entry After Renovation

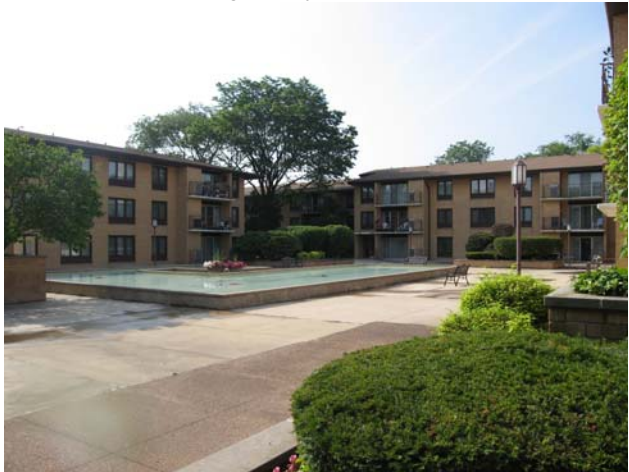
View of Courtyard Prior to Renovation

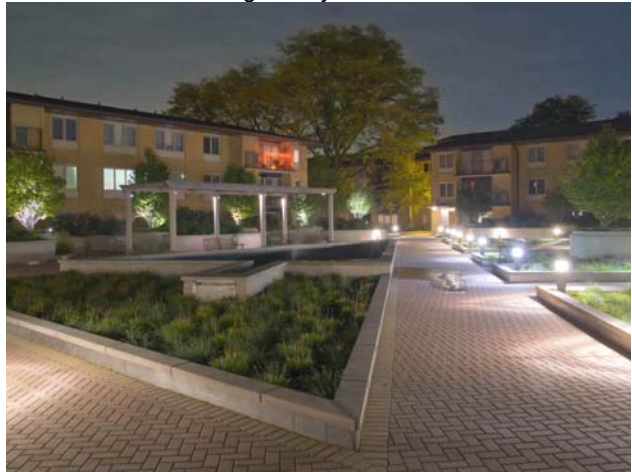
View of Courtyard After Renovation

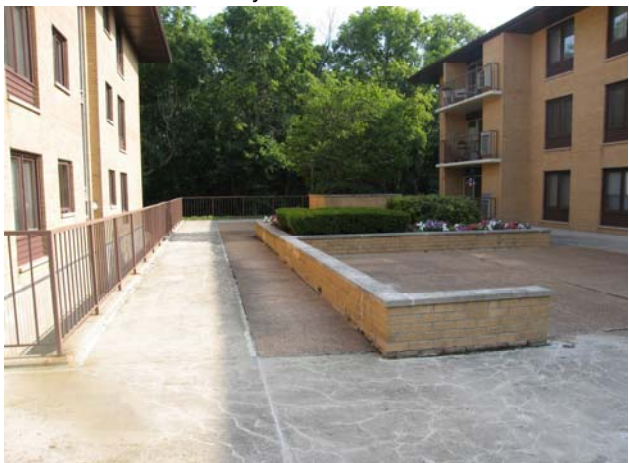
View of Courtyard Prior to Renovation

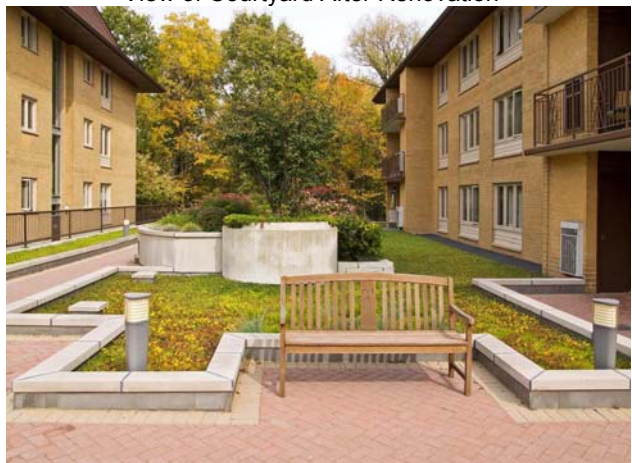
View of Courtyard After Renovation
