170,000 s.f. Roof Assembly Tear-Off & Replacement
Park Ridge, IL

Client:

Bristol Court Condominium Association

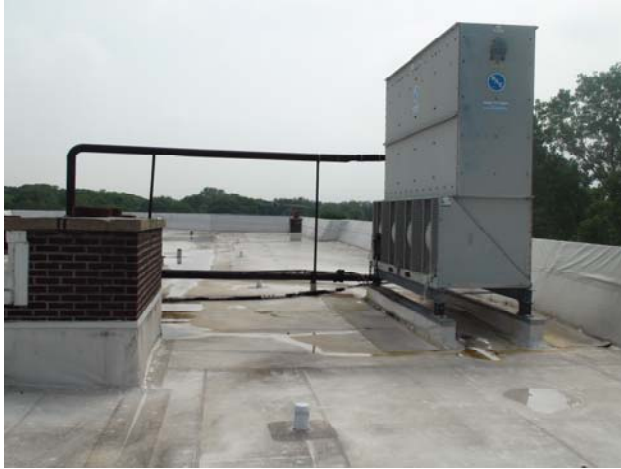
View of Existing Damaged Roof

An intense hail storm damaged all aging roofs of this suburban condominium complex of 14 four-story multi-residential buildings. The roofs could not be repaired. The insurer stipulated that the buildings be re-roofed for the budget of in-kind replacement to best match the original construction appearance from grade.

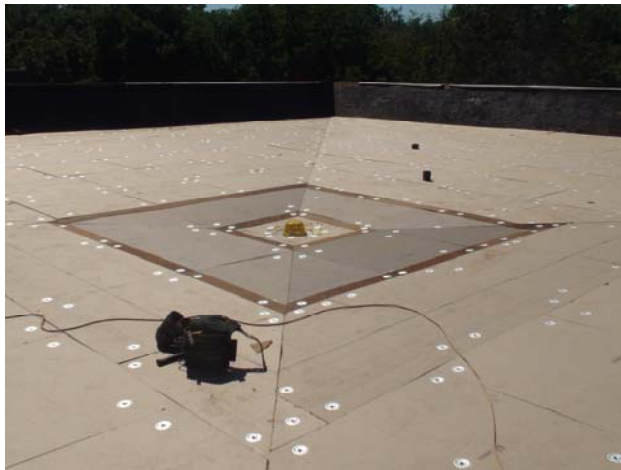
Installation of replacement R-20 Insulation

- A ±170,000 s.f. low slope, low albedo (reflectance) mechanically-fastened PVC membrane with a 15 yr. material / 5 yr. labor warranty
- Factory Mutual 4470 compliant impact resistance, hail damage resistance, wind uplift resistance and exterior fire resistance standards
- Energy code-compliant replacement insulation
- High quality replacement drains for areas of heightened insulation for all roofs
- The additional design of an ±90,000 s.f., 25 yr. material / 3 yr. labor warranted cedar shake mansard replacement roof assembly

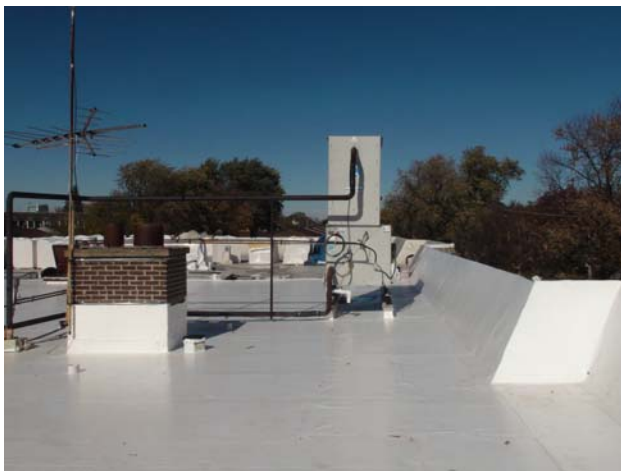
View of Completed Replacement Roof

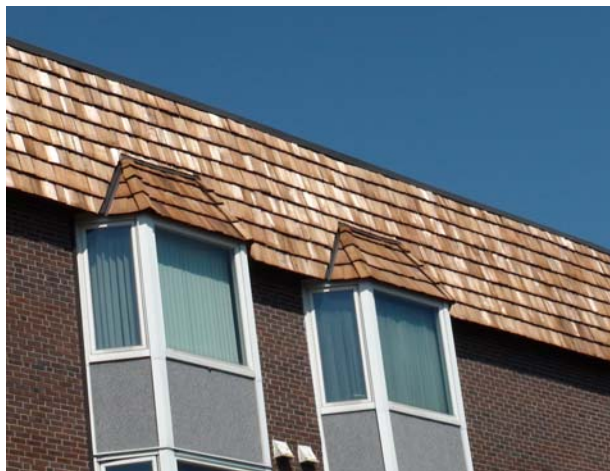
Detail of Cedar Shake Replacement Roof Assembly
